# Kinder Catchment Monitoring Project

## Final Report

Moors for the Future Partnership

2015

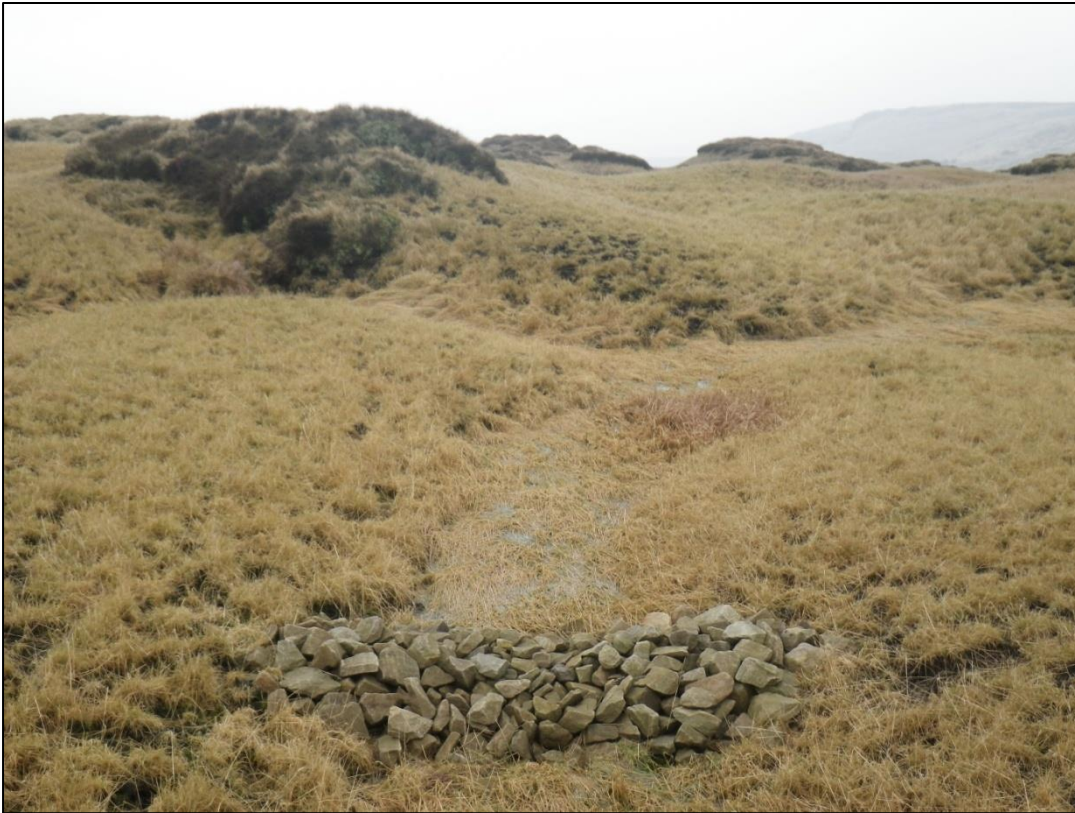
Figure 10 - example of a gully block on Site BG, March 2014.

The gully blocks surveyed on the Kinder Plateau are all still intact and in good condition, with no visible maintenance issues. A visual inspection of 83 gully blocks suggests that the vast majority of dams are trapping sediment and holding back water. In addition, 94% of

dams surveyed are showing signs of vegetation establishment on re-deposited sediment (Figure 10).

These results demonstrate the success of gully blocking undertaken within the Kinder Catchment Project and serve as a baseline should any future surveys be undertaken.

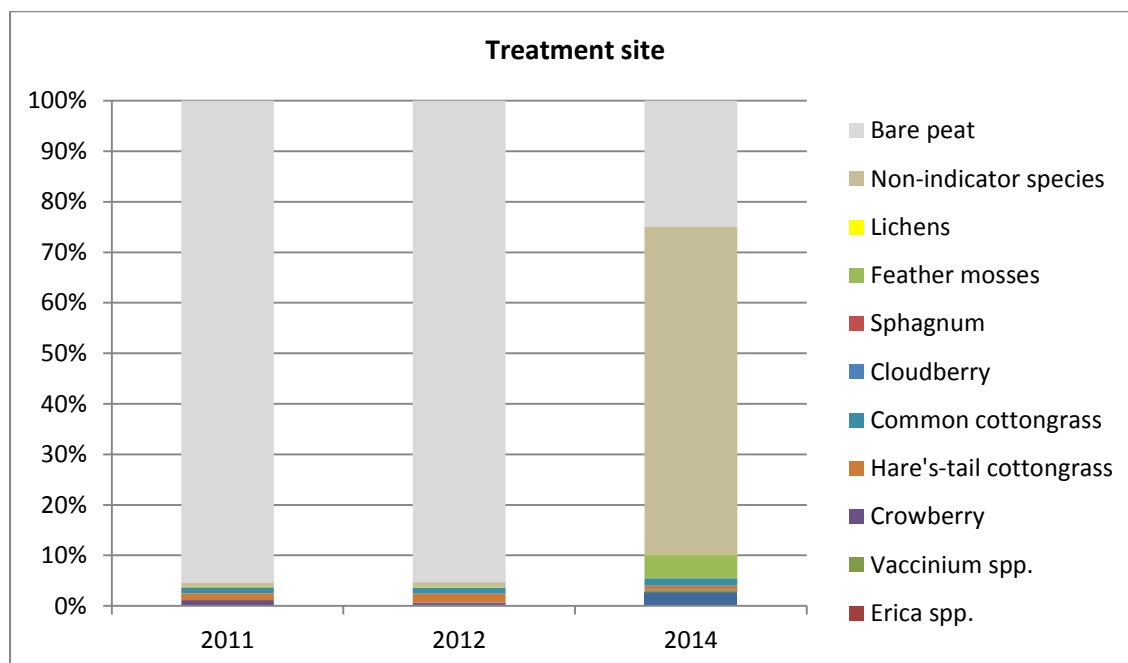
Figure 19 – mean proportion of surface type/ plant type cover present across treatment sites during each survey year

In addition, hare's-tail cottongrass and Ericaceous species (i.e. dwarf shrub species) collectively should not exceed 75% of the vegetation cover. Figure 19 shows the proportion of vegetation cover within quadrats. On treatment sites it can be seen that, on average, bare peat and non-indicator species dominate quadrat area. Ericaceous species and hare's-tail cottongrass do not make a significant contribution to the cover of quadrats in 2014.

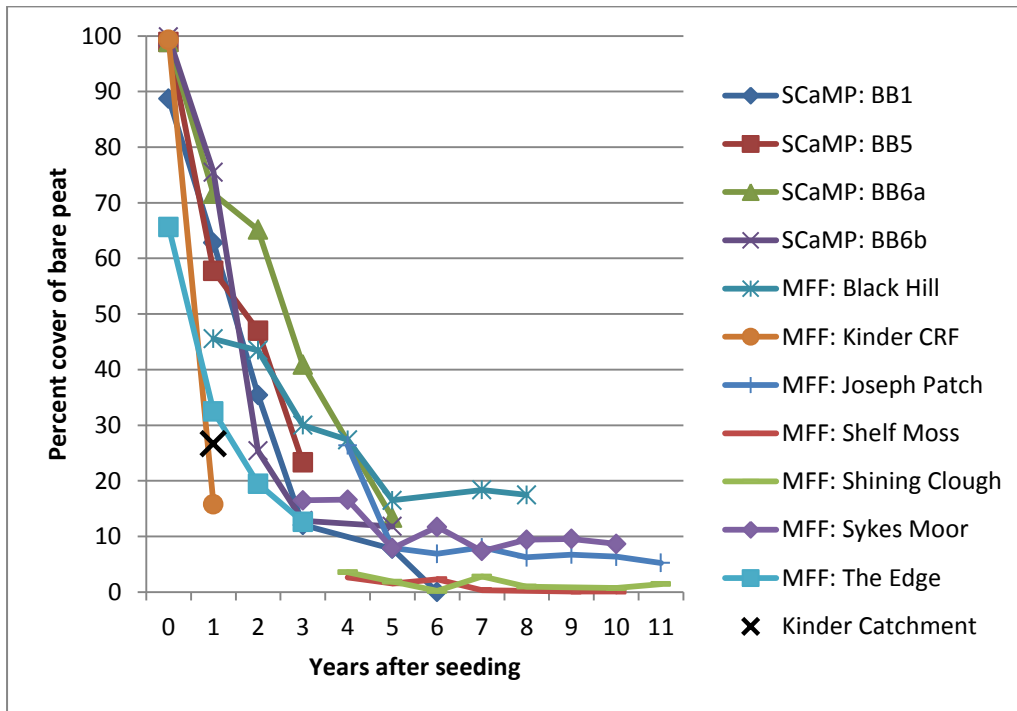
Figure 24 - changes in bare peat cover across multiple sites over 11 years

Following seeding, all sites demonstrate an immediate decrease in bare peat which continues for between four and five years (Figure 24). After five years the proportion of bare peat appears to level off for all sites and remains low and stable. The sites vary in the degree to which bare peat is reduced, but common patterns appear to be present.

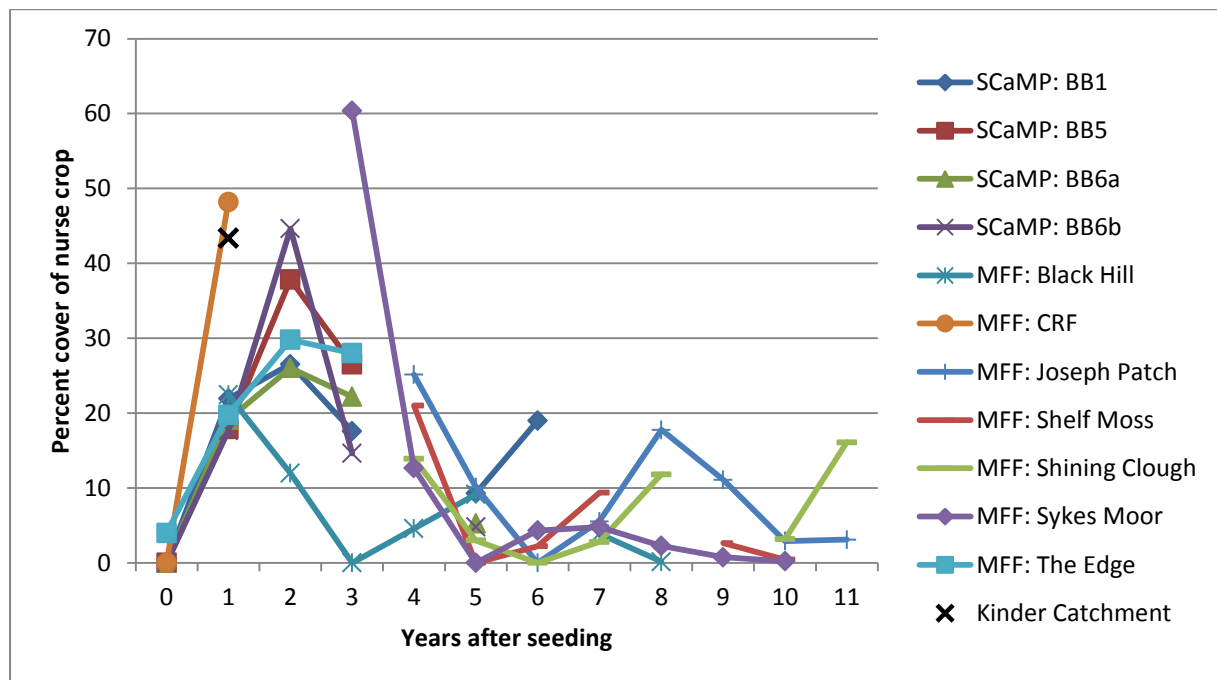
Figure 26 - patterns of change in nurse crop cover across multiple sites over 11 years.

Nurse crop cover establishment at Kinder Catchment monitoring sites was significantly higher compared to most other sites one year post seeding ( $F = 42.054$ ,  $p < 0.01$ ). Post-hoc tests showed that Kinder Catchment quadrats had a significantly higher proportion of nurse crop than all other sites, except for CRF quadrats which did not differ significantly.

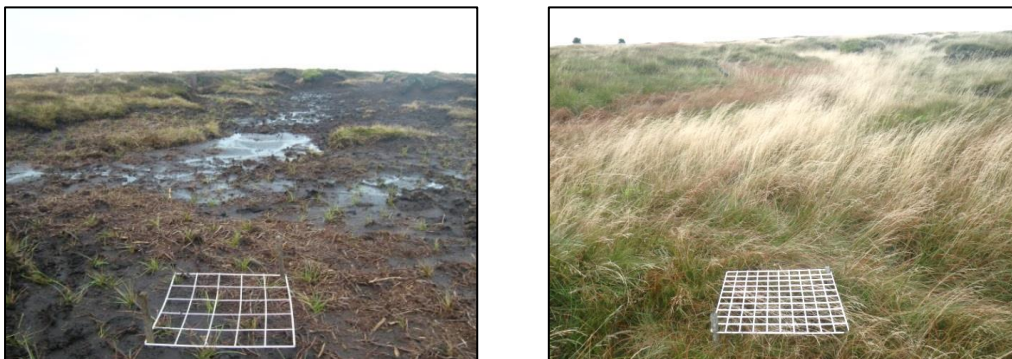
Percent cover of cottongrasses remain low, however this could be down to the siting of quadrats rather than a genuine absence. Quadrats have tended to be sited on the 'hard-to-win' drier areas rather than in hollows, which would be where cottongrasses would establish first. Return visits to historic plug planting undertaken as part of the Biffa project have shown that cottongrass plug plants showed have been very successful in colonising the areas around where they were originally planted (Figure 28). These Biffa sites are within the Kinder Catchment project area and were treated with lime, seed and fertiliser between 2012 and 2014. Fixed point photos indicate that plug planting has contributed to the transformation of the areas which were planted up, with cottongrasses clearly visible amongst the grasses.

Figure 28 – Fixed point monitoring photos from 2010 and 2014. These quadrats were set up to monitor plug plants as part of the Biffa funded 'Peatlands for the Future' project. They were revisited at the end of the Kinder Catchment Project to record the progress of areas planted with common cottongrass. Lime, seed and fertiliser applications were undertaken during the Kinder Catchment Project in 2013.

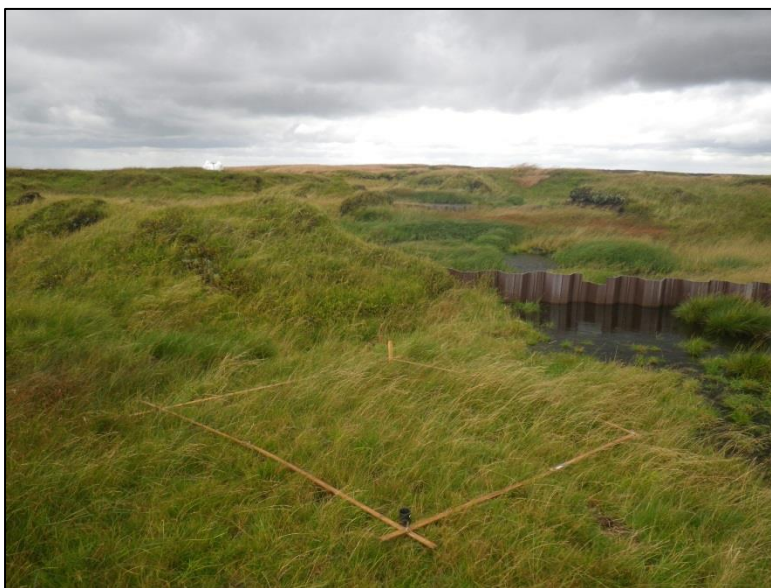
National Vegetation Classification plant communities associated with the sites also suggest that vegetation at site BF has developed differently to the other two treatment sites throughout the monitoring period. This site is most strongly associated with M20 *Eriophorum vaginatum* blanket and raised mire communities and subcommunities. This again suggests the site is wetter overall, and more similar to the intact reference site than the other two treatment sites. This is likely to be because of the proximity of plastic piling to several of the quadrats (Figure 29) and the resulting high water table.

Figure 29 - quadrat on site BF - many quadrats here were in close proximity to plastic dams

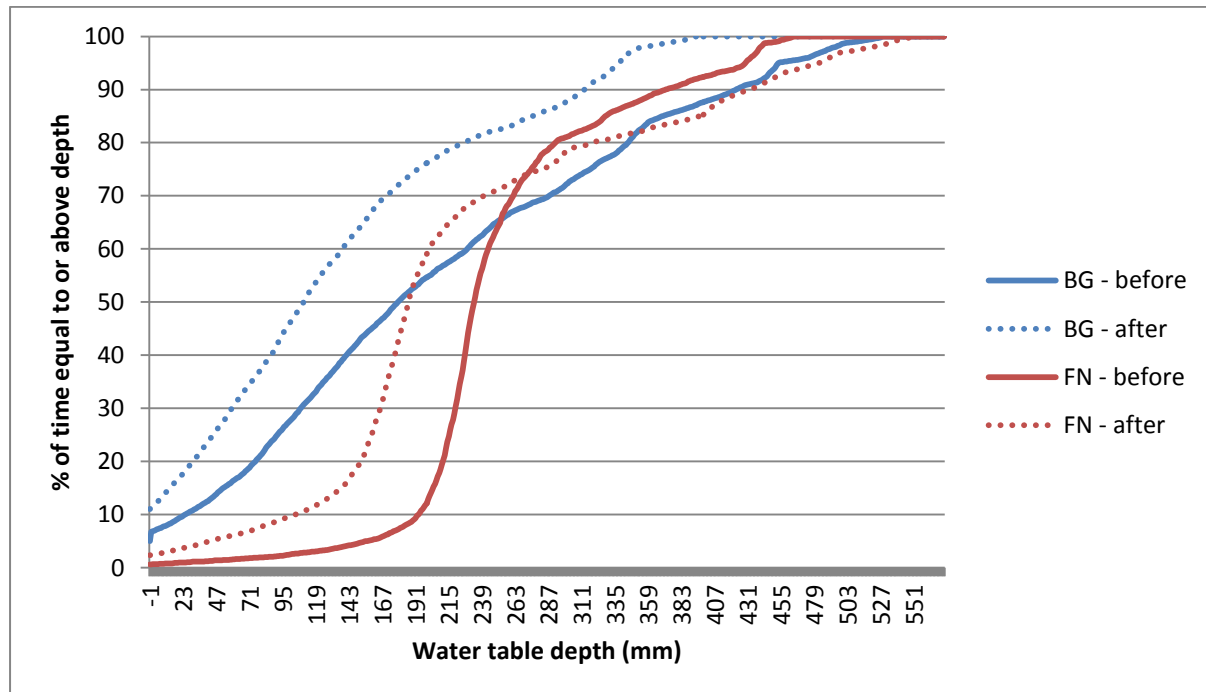
Figure 35 - cumulative frequency graph showing behaviour of water table at BG (treatment) and FN (bare peat reference) before and after re-vegetation.

seeding, water table at BG demonstrated a change in temporal pattern, while FN showed little change in temporal pattern.
