# MoorLIFE: Active Blanket Bog Restoration in the South Pennines Moors

## Monitoring Programme – Mid-Term Report

November 2013

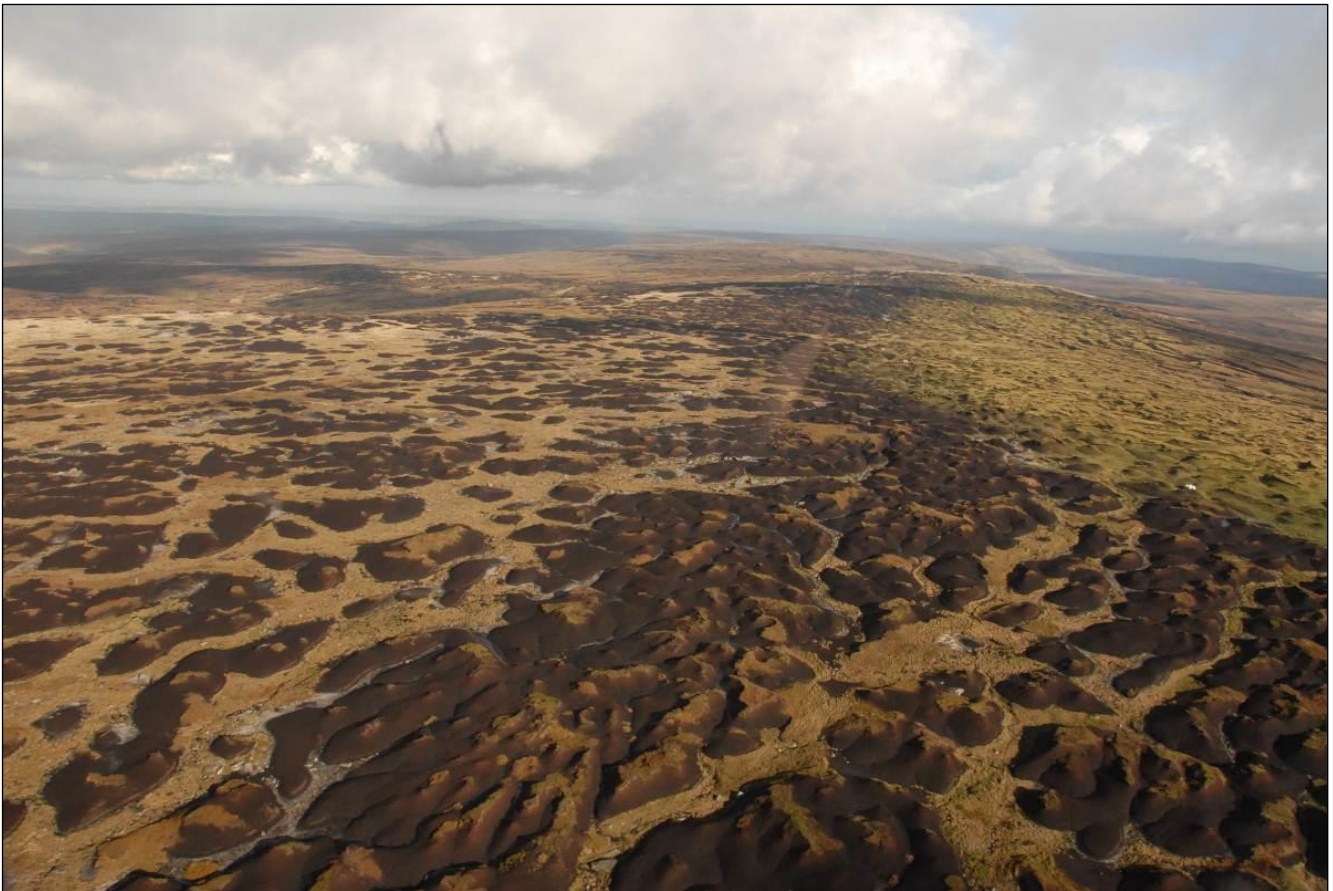
**Figure 2** Part of the Bleaklow plateau, showing large areas of bare and eroding peat. The area of pale green to the top right of the image shows Alport Moor, which has already undergone peat stabilisation treatments. The MoorLIFE project is enabling the Moors for the Future Partnership to stabilise the last expansive areas of bare peat on the plateau.

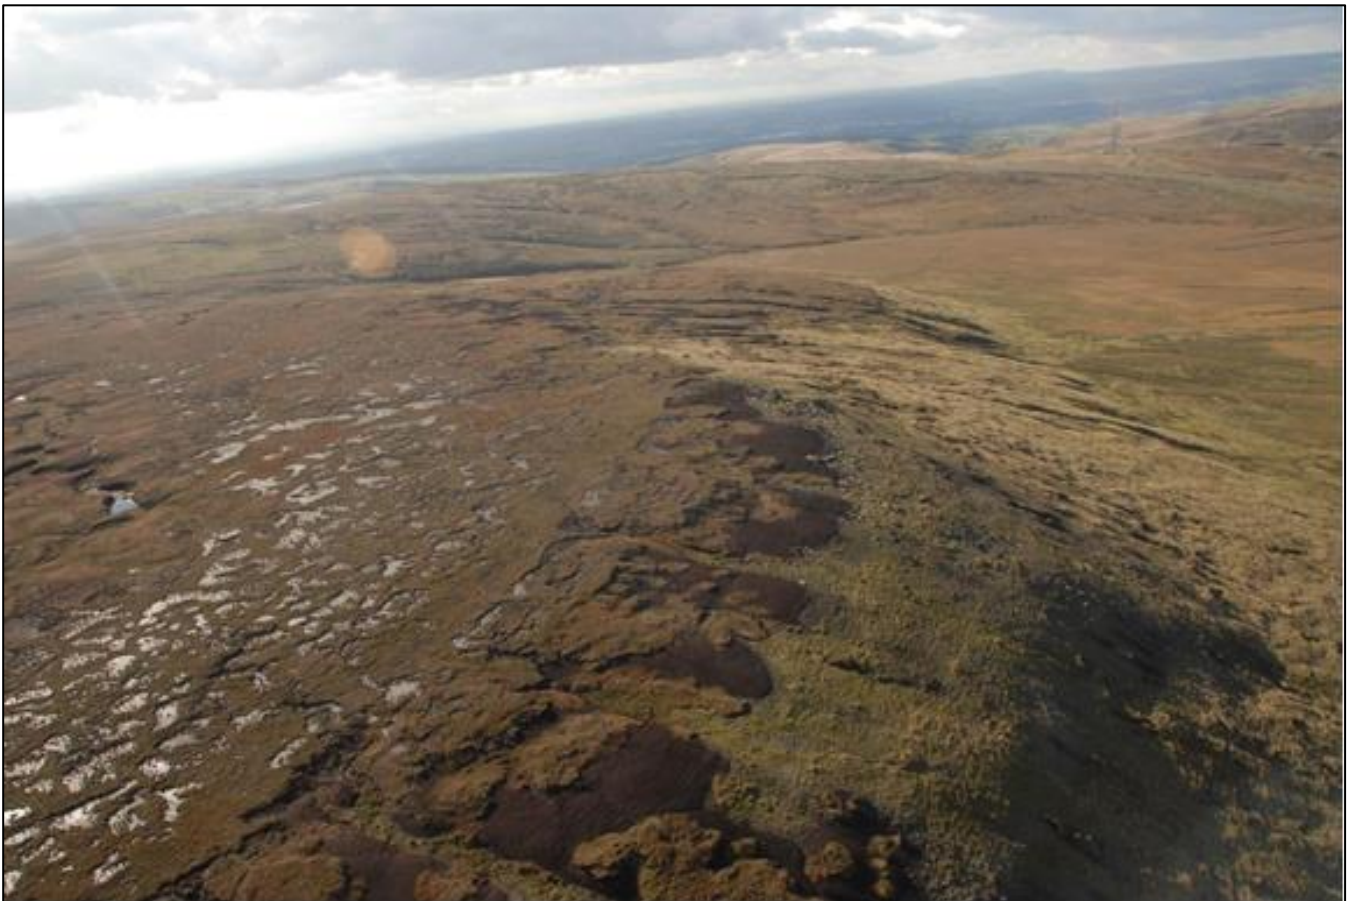
**Figure 6 Aerial view of Rishworth Common looking west, showing the M62 motorway to the north of the site. Rishworth Common has substantial areas of bare and eroding peat on its north-facing slopes. On the flat tops the degradation takes the form of peat pans.**

Rishworth Common, to the north of the Peak District National Park, is receiving full bare peat stabilisation and diversification. Vegetation, water table and water quality monitoring has been established across three main areas of bare peat that are being treated with brash, LSF applications, and *Sphagnum* propagules. A small 'reference' area of bare peat within the main treatment area has been left untreated to enable a reference site to be retained. This area is essential to enable a robust assessment of the impact of the peat stabilisation works on vegetation and hydrology. In addition, a large flat area of Rishworth Common consists of 'peat pans' which can be clearly seen in Figure 6. Water table monitoring is undertaken on the north side of the M62 motorway to monitor the hydrology of these peat pan areas. An 'intact' reference site approximately 500 metres from the main works area enables a comparison to an area relatively undamaged by erosion.

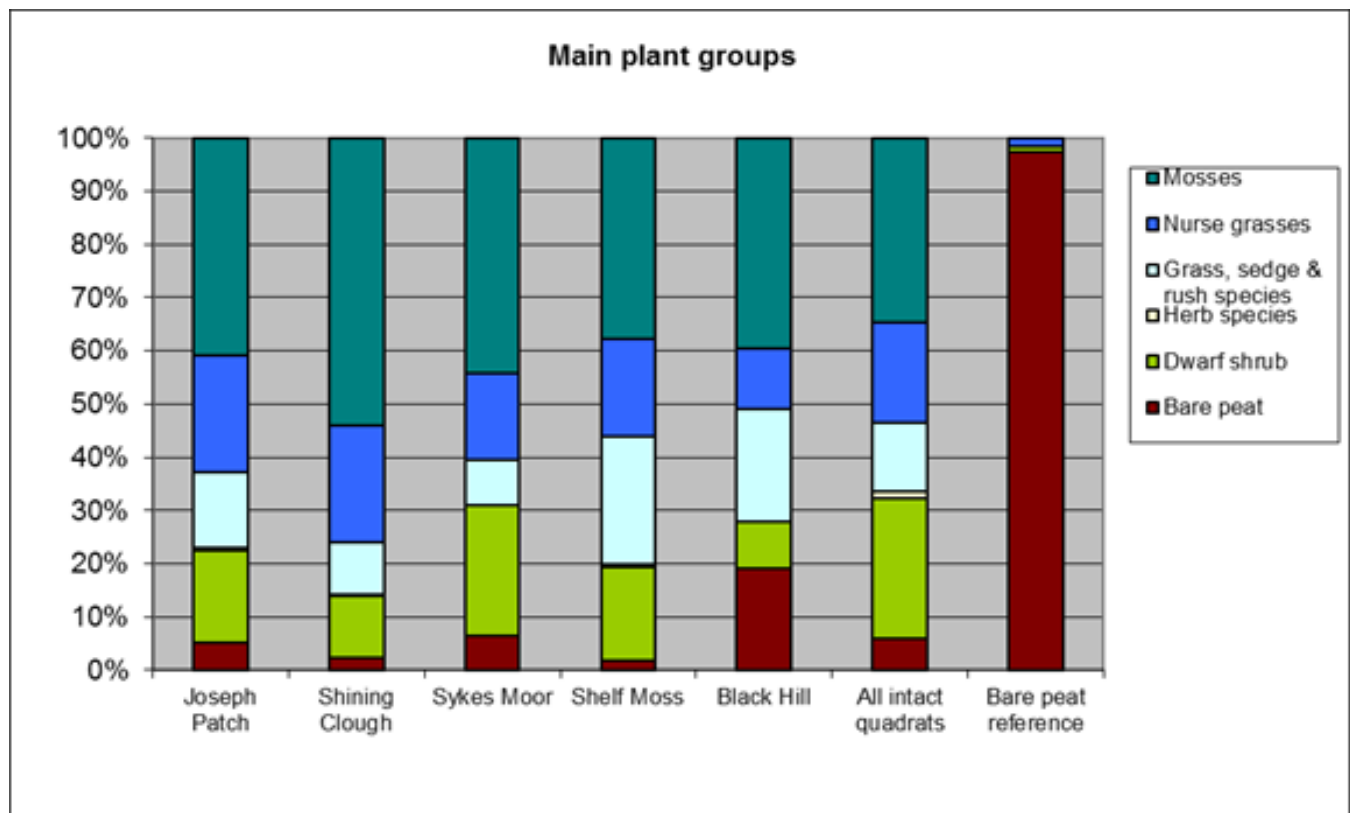
Figure 10 Percentage composition of main vegetation cover types on late-stage restoration sites

sites, but with herb species present in higher proportions. These figures are a representation of the relative dominance of vegetation groups (a complex vegetation structure means that totals often added up to more than 100%). Median percentage cover values are presented in Table 5.

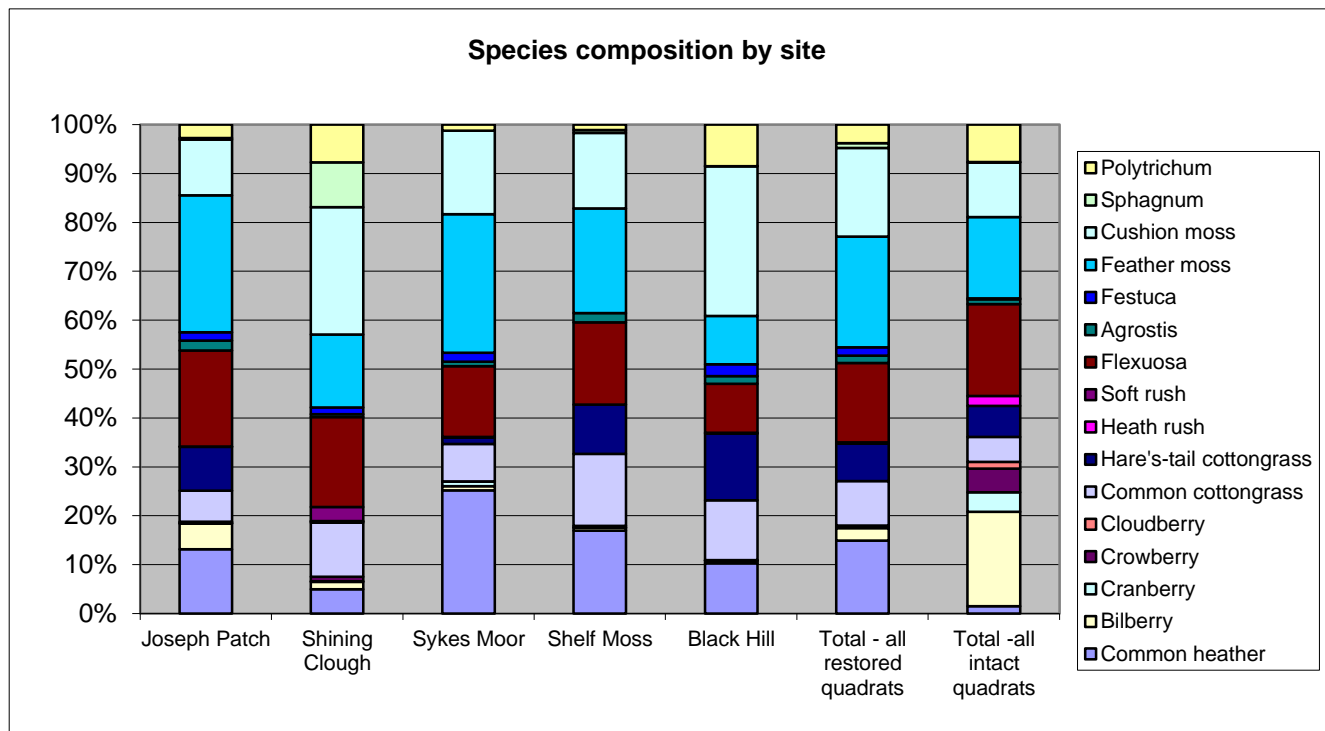
**Figure 11 Percentage composition of the most common species and species groups found on late-stage restoration sites**

Figure 11 shows the species composition of the late-stage restoration sites, along with intact hagg tops within those sites. Again it is important to note that these charts do not present mean percentage covers – simply a representation of the relative abundance of each species within the vegetation.

Again the variability of species composition can be observed, but with broad patterns. The most abundant species occurring were common heather, bilberry, common cottongrass, hare's-tail cottongrass, and wavy hair grass. Within the bryophytes, both feather mosses and cushion mosses (those excluding *Polytrichum* sp.) were present in high proportions.

The main observed difference among restored sites appears to be in bryophyte composition. Feather mosses were generally more predominant than cushion mosses, with the exception being Black Hill where the reverse appeared to be true. *Sphagnum* mosses were not abundant on any site with the exception of Shining Clough where they appear to make up a relatively large proportion of the vegetation. Examination of the data however shows that just three out of 15 quadrats contained *Sphagnum*, with one quadrat having 90% cover – indicating that one quadrat could be responsible for the high figures.

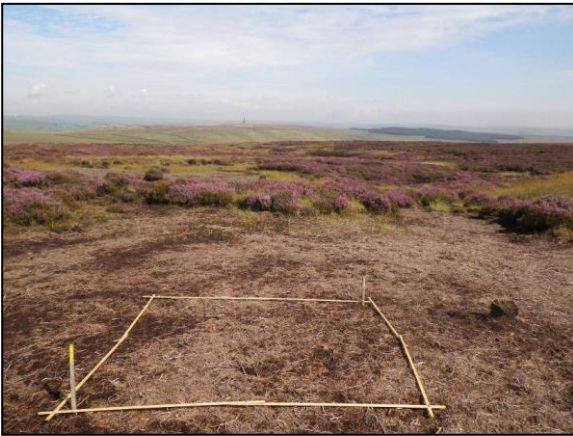
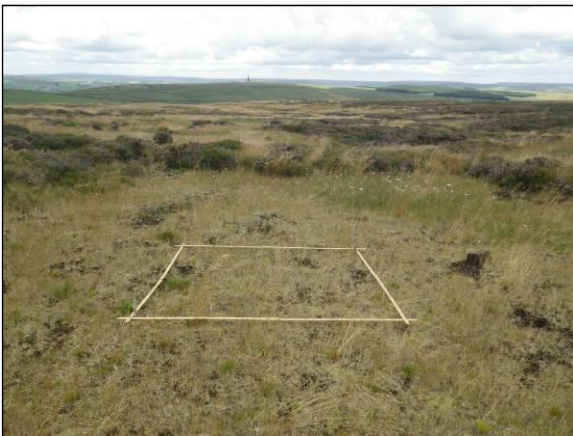
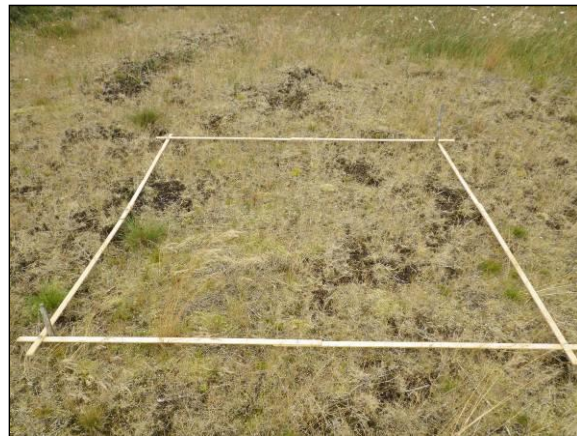
**Figure 14 Fixed point photography of quadrat 8 on Turley Holes in three years of data collection. Quadrats were established in winter 2010 (photos (a) and (b)), prior to any works being undertaken. Brash was spread over the site in the following months and can be clearly seen in photos (c) and (d) taken in the 2011 survey. The site was treated with lime, seed and fertiliser between 2011 and 2012, resulting in a covering of nurse grasses by 2013, shown in photos (e) and (f).**

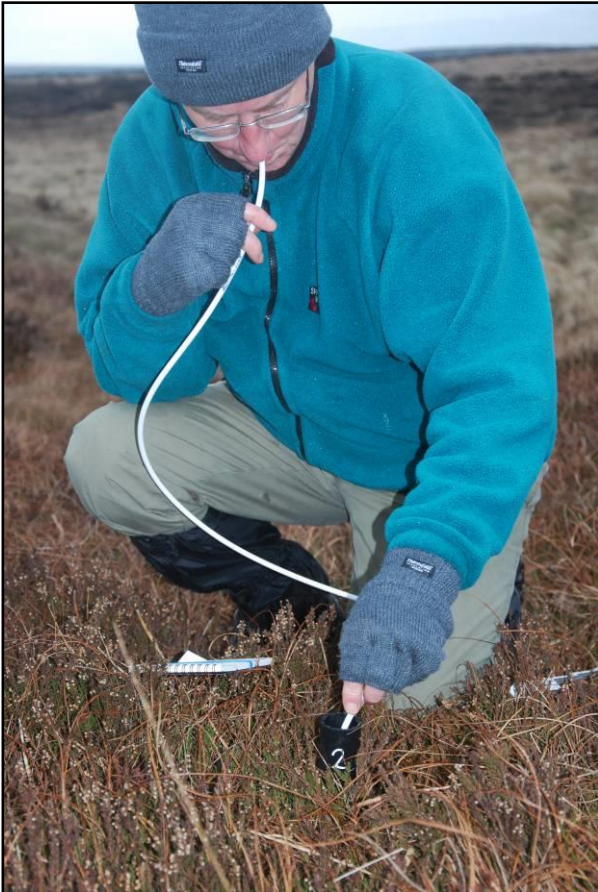
point at which that bubbling is heard is the depth of the water. The length of pipe between the water and the top of the pipe is noted, and the length of the dipwell that is above the peat is then subtracted from this measurement to give the depth of the water table below the peat surface.

**Figure 17 Measuring water table depth**

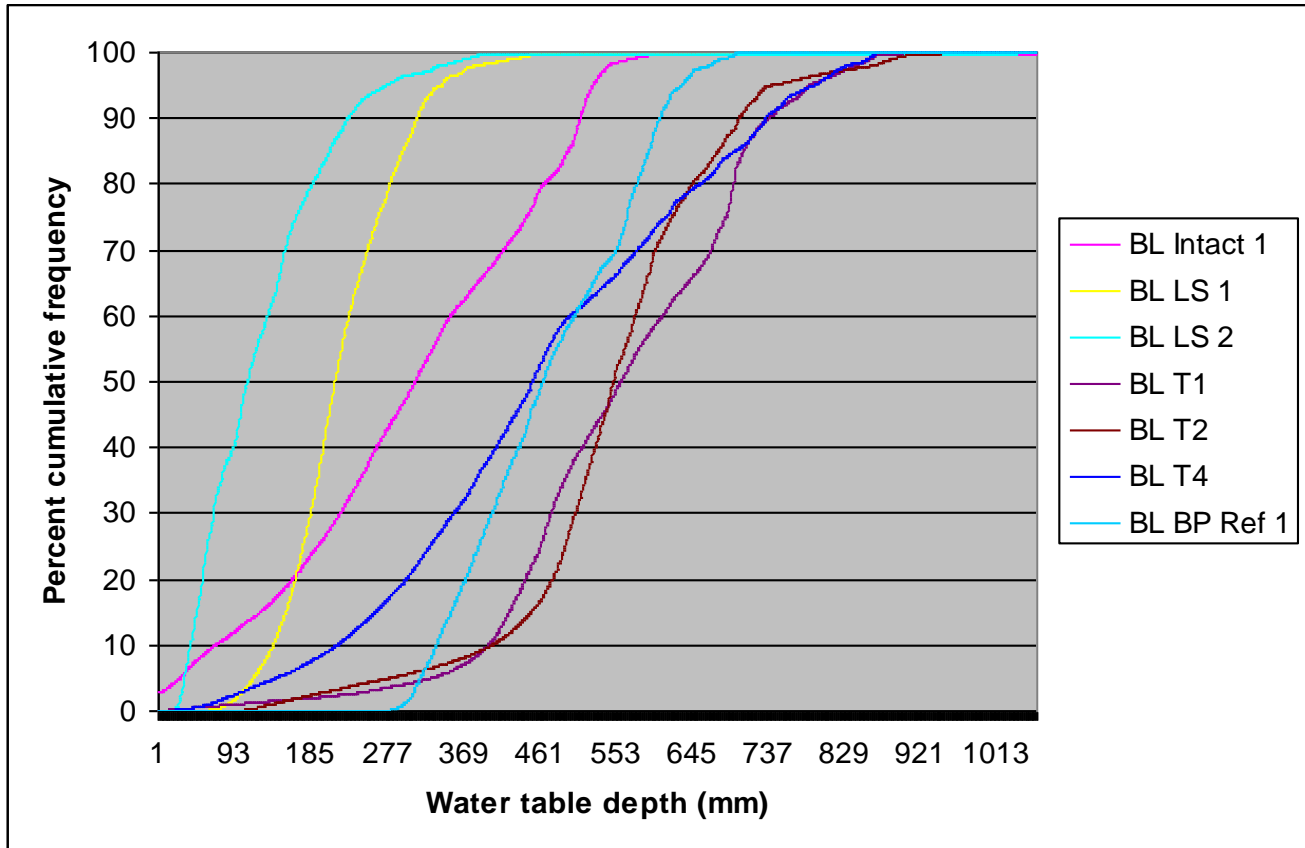
**Figure 23** Cumulative frequency curve of water table on Bleaklow, showing the proportion of time water table spends at each depth. Graphs indicate the proportion of time the water table is higher than each water table depth. LS refers to late-stage restoration sites, T refers to treatment sites, and BP Ref refers to an untreated area of bare peat being used as a reference site.

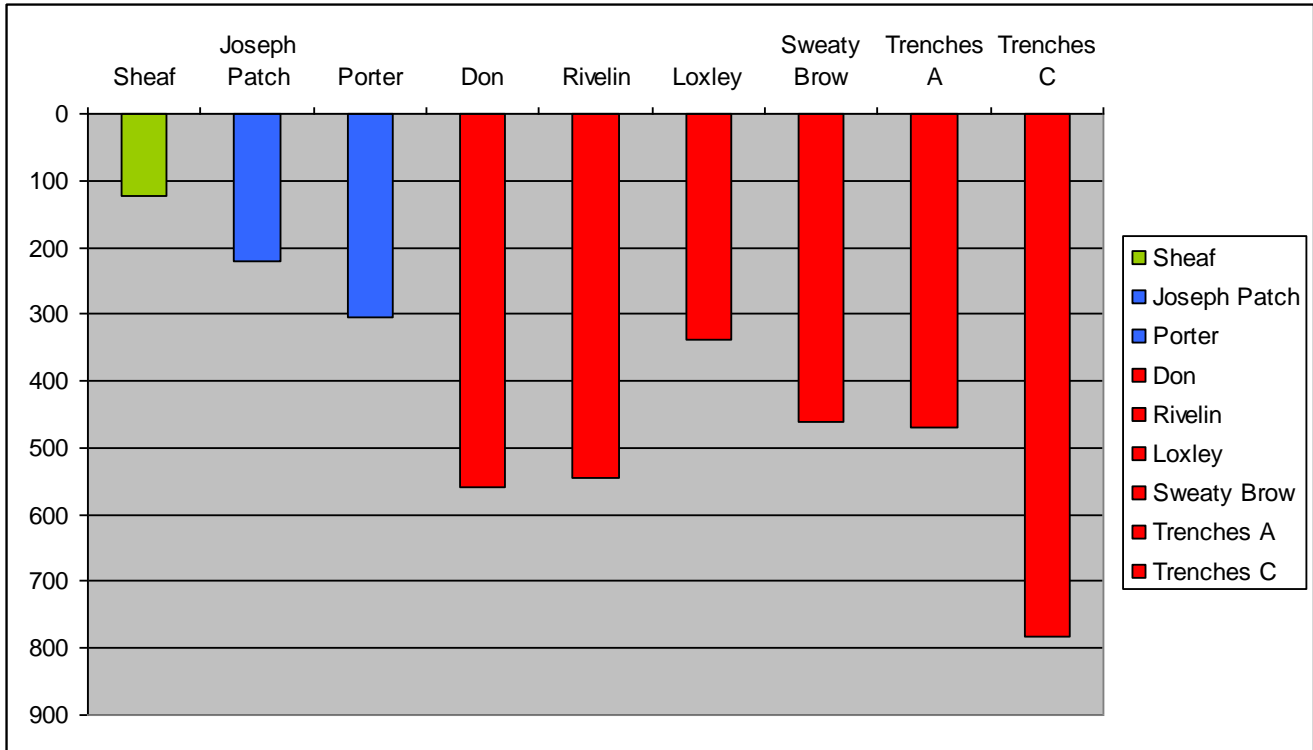
**Figure 24 Mean water table calculated from hourly water table measurements taken over a 2 year period on Bleaklow.**

This data suggests a pattern of the degraded sites, shown in red, with low mean water tables, intact sites having a high water table, and the late-stage restored sites having an intermediate water table. The variation in the mean water table of degraded sites is again demonstrated, although this has not been statistically tested at this stage.

The mean water table depths as calculated from the automated dipwell data are shown in Figure 24. These means differ from the autumn water table depths as they are calculated from points collected through all seasons and over a two year period.

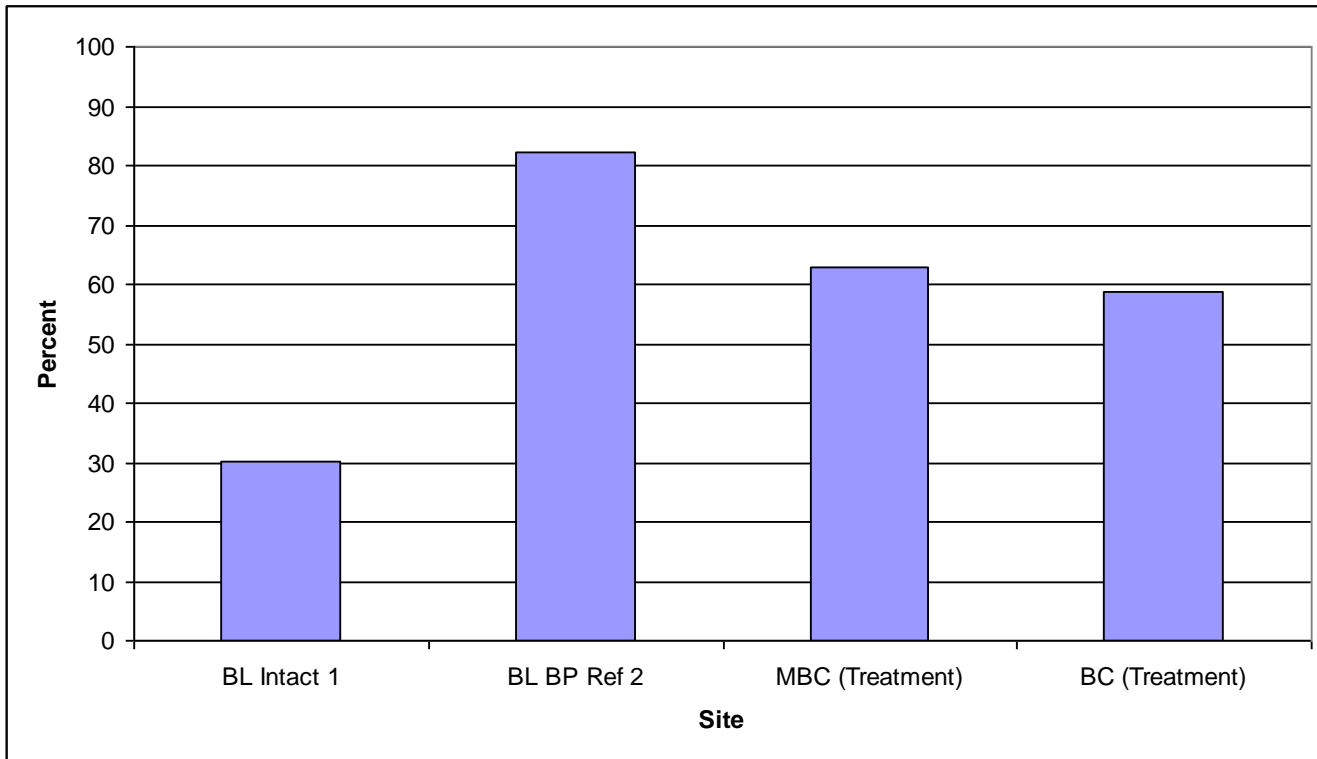
**Figure 26 Proportion of water samples containing detectable levels of POC. BL-Intact-1 and BL-BP-Ref-2 are sites being monitored as reference sites for comparison of treatment areas. MBC and BC are two streams draining the Woodhead area of Bleaklow.**

On Bleaklow, the water draining the bare peat reference site (BL-BP-Ref) has the highest level of POC, with a median concentration of 5 mg/l. This concentration is significantly higher than the other three sites (BL-BC,  $Z = -2.90$ ,  $p < 0.05$ ); BL-MBC,  $Z = -2.815$ ,  $p < 0.05$ ; BL-Intact,  $Z = -3.63$ ,  $p < 0.001$ ). Most samples (82%) contained detectable levels of POC suggesting that levels of erosion on this site are higher than the other catchments (Figure 26).

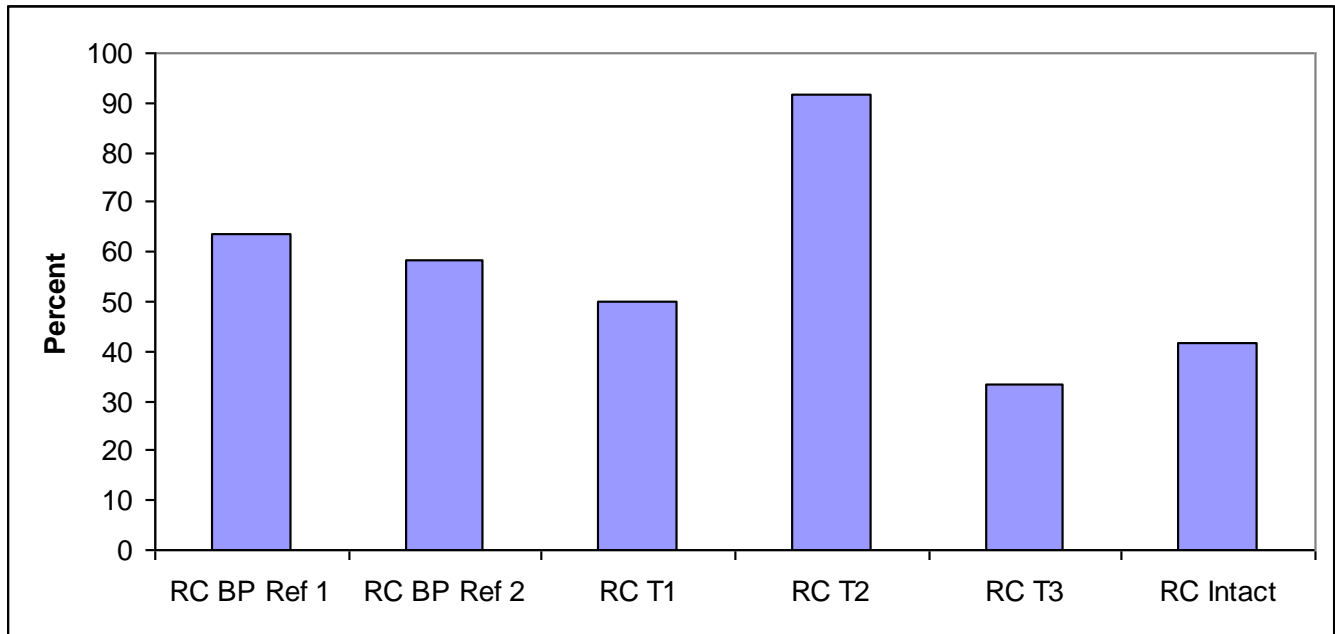
**Figure 31** Proportion of samples from Rishworth Common containing detectable levels of POC. BP Ref indicates untreated, bare peat reference sites, T indicates treatment sites. See Table 11 for more information regarding Rishworth site codes.

POC concentrations were highest in RC-BP-Ref 1 and RC-T2, both with medians of 5 mg/l, followed by sites RC-BP-Ref-2 and RC-T1 (both 1.5 mg/l). Sites RC-T3 and RC-Intact had medians of 0 mg/l. The proportion of samples that contained detectable levels of POC also varied across sites and are summarized in Figure 31.

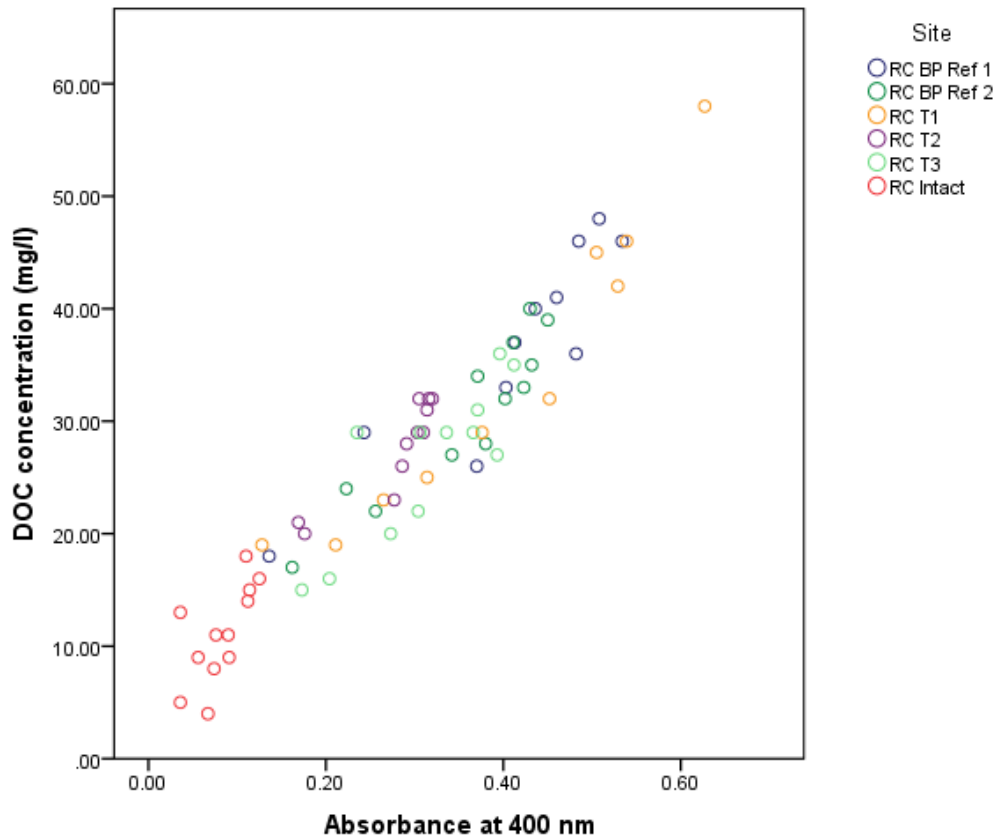
**Figure 33 Relationship between absorbance at 400nm and DOC concentration of water samples taken from Rishworth Common**

The relationship between DOC and absorbance at 400nm again is strong and positive, with less drift than Bleaklow. Spread of data points reflects the range and variation in water quality seen in water samples. The intact reference site appears to exhibit strong clustering and does not overlap with the other sites.

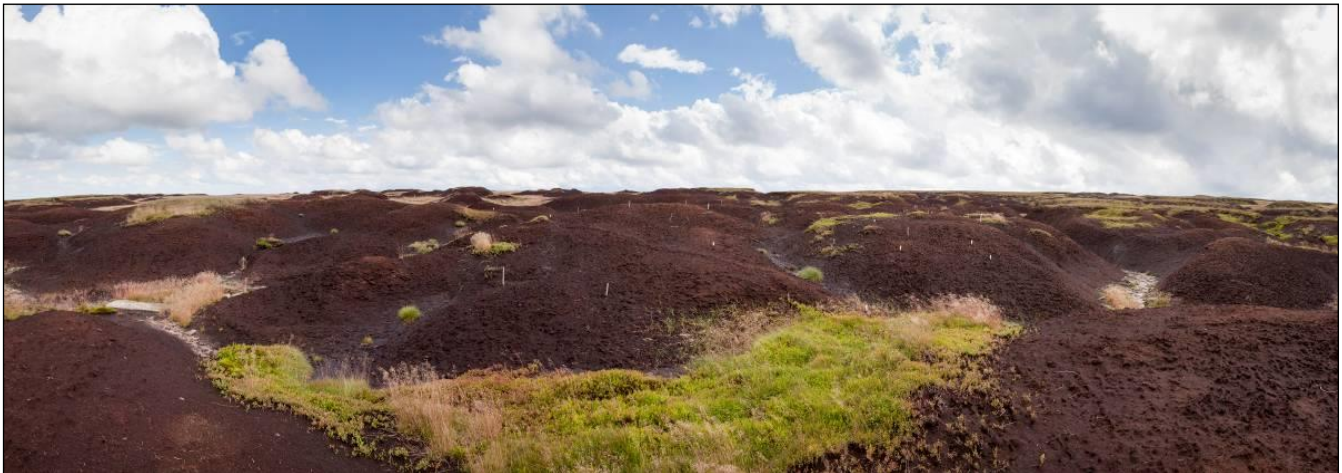
**Figure 34 Dipwell cluster at site BL-BP-Ref – an untreated bare peat area.**

The dipwell clusters that are part of the MoorLIFE project have a range of different topographical settings that should be taken into account in the final analysis of water table condition. Some of the different topographical settings can be seen in Figures 34 to 36.

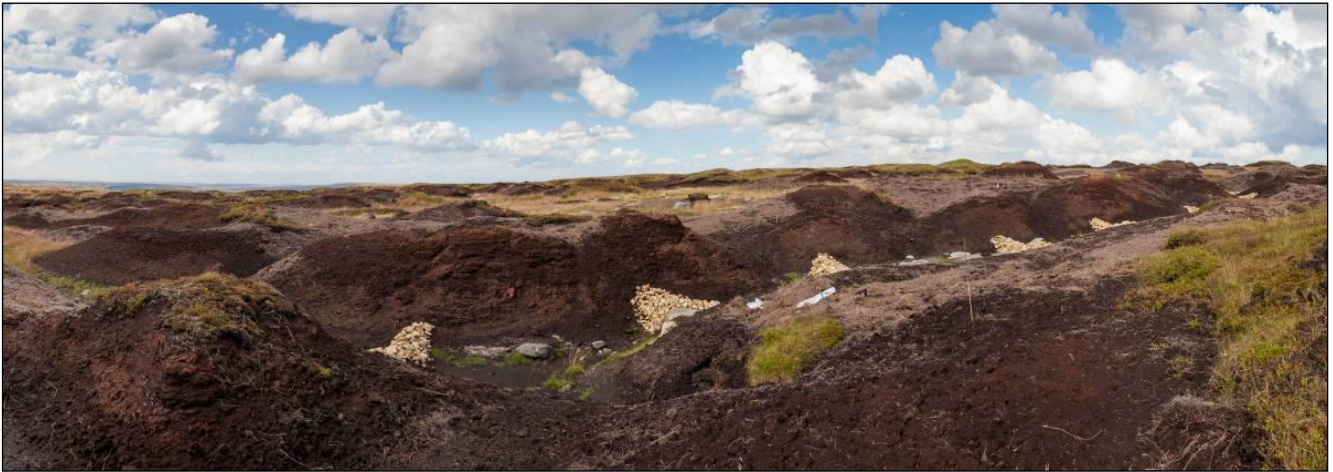
**Figure 35 Dipwell cluster and gully blocks at site BL-T1 on Bleaklow.**

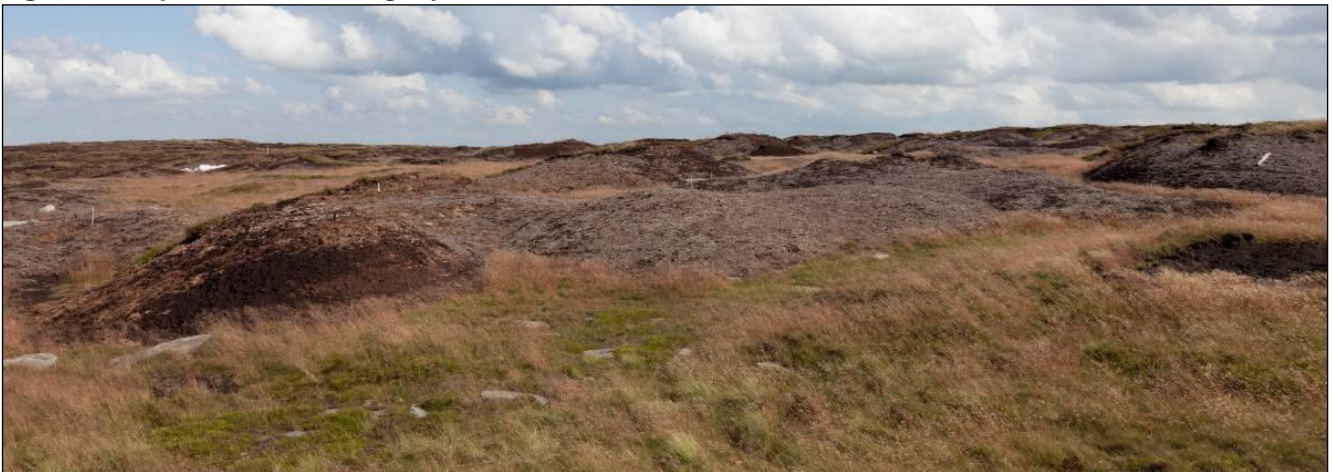
**Figure 36 Dipwell cluster at site BL-T3. These dipwells are in islands of peat surrounded by large areas of mineral soil.**

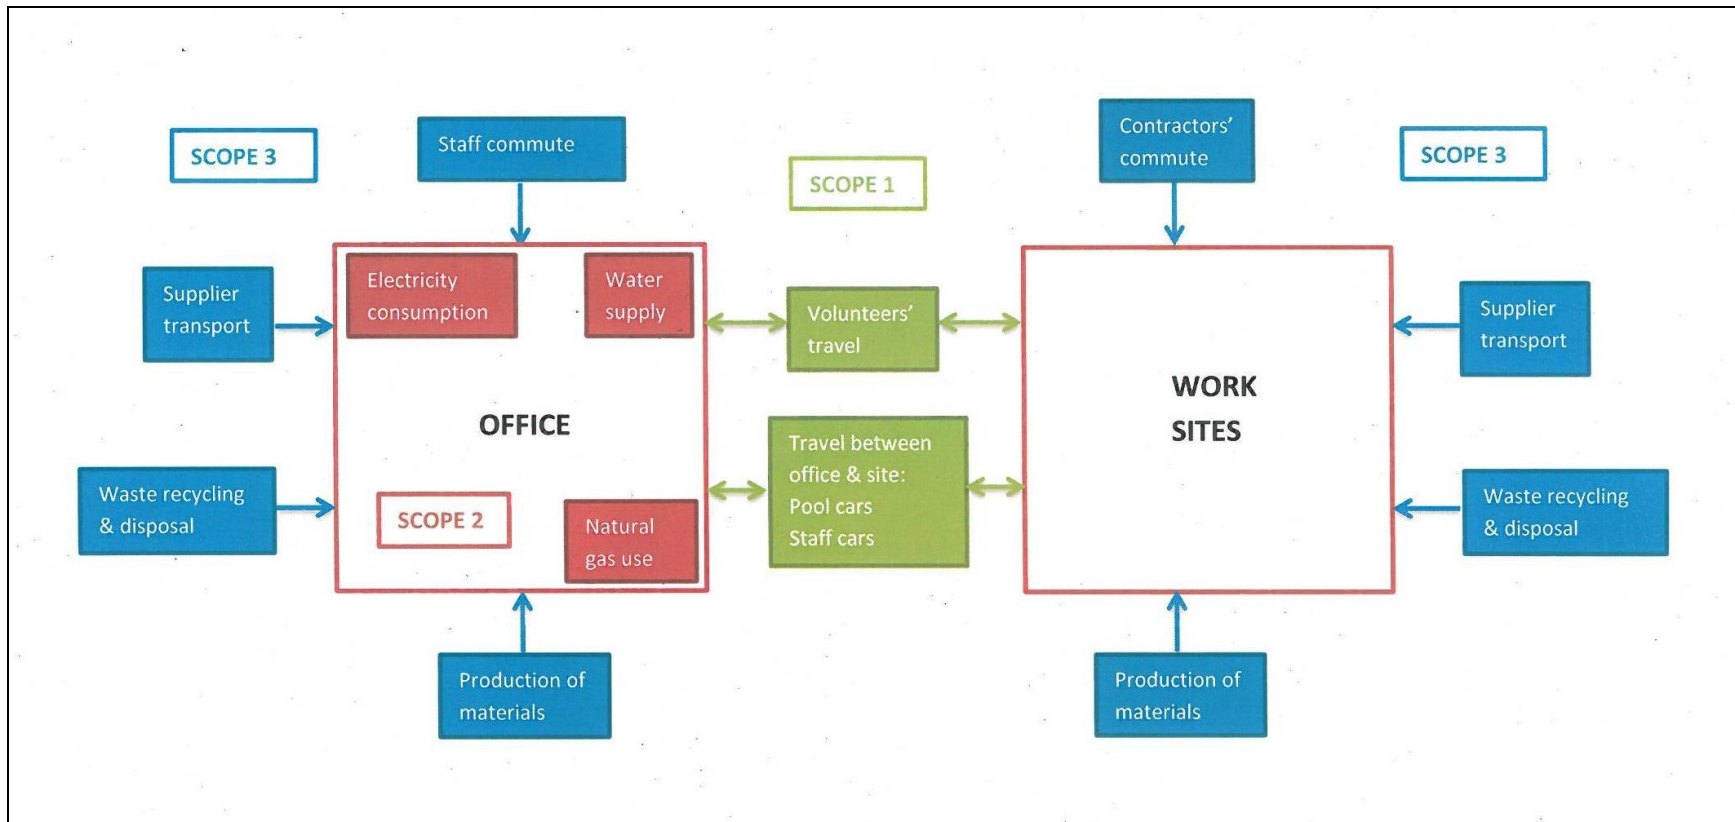
Figure 37 Categorisation of types of GHG emissions into the scopes as defined in the Defra (2009) guidelines.
