From Cairns to Craters: Conservation Heritage Assessment of Burbage

Moors for the Future Report No 8

Dr Bill Bevan

2006

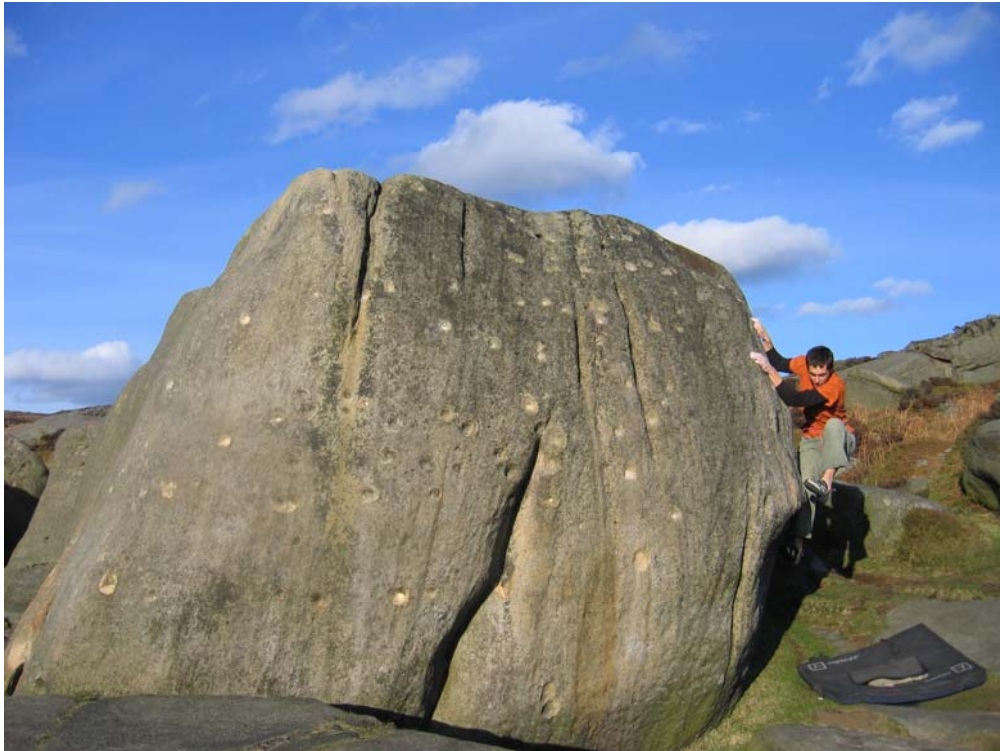
Illustration 10. World War 2 bullet scars used by climbers for bouldering. Philippa Davey.

The evidence for military training stretches across a large area of the Burbage Valley (431.19, 431.41, 431.54, 431.65, 431.66). It comprises numerous earthfast boulders scarred with bullet holes, mortar shell scars and at least four filled-in foxholes. Some of the boulders give the appearance of concrete pill boxes. The majority of boulders are usually hit only on one side. To the south-east of Carl Wark and below the southern part of Burbage Edge there are groups of shot boulders that appear to show areas where troops advanced in one direction as if assaulting a series of positions. Where these trails of bullet-ridden rocks stretch for hundreds of metres, the direction of assault is always uphill. There are also at least four foxholes (square pits with earthen embankments dug as defensive positions), including three in an approximate line at SK267815 that face north-east towards part of Burbage Edge where boulders are covered in a dense pattern of bullet and mortar scars. An outcrop just south of Upper Burbage Bridge was also the scene of a ferocious assault.

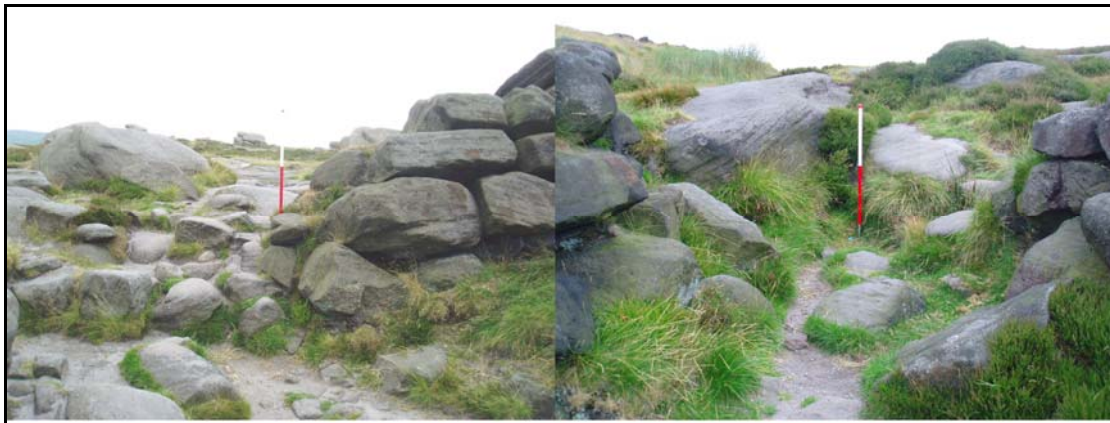
Illustration 11. Footpath erosion on Carl Wark. Left: northern end of western rampart. Right: entrance.

There is erosion on one footpath which passes across Carl Wark (431.1), causing damage to the northern terminal of the western rampart and to the ground surface at the southern entrance. Repair work has been undertaken to the footpath approaching the western end of the rampart from Higger Tor (Ullathorne and Rylatt 2004). The footpath requires monitoring where it crosses the Scheduled Monument, and consideration should be given to redirecting the path to the west of the scheduled area.

The entrance is on the line of a right of way. The steep ground has resulted in erosion of the ground surface which has undermined the wall to either side of the enclosure. Footpath stabilisation and repair has halted damage from erosion at present. The area requires regular monitoring to assess future condition and check for continuing erosion. This is a very important area within this important monument and, therefore, any potential further erosion must be prevented.

The northern end of the western wall is crossed by a right of way that passes through an existing gap in the wall created by collapse or robbing of the fabric. There is a small amount of ground surface erosion on steep ground immediately outside the wall and across the surviving foundations. At the time of the survey, the wall fabric itself did not appear to be suffering from obvious damage. In November 2004, repairs had been made to the footpath approaching the western end of the rampart from Higger Tor (Ullathorne and Rylatt 2004). The area requires regular monitoring to check for continuing erosion.

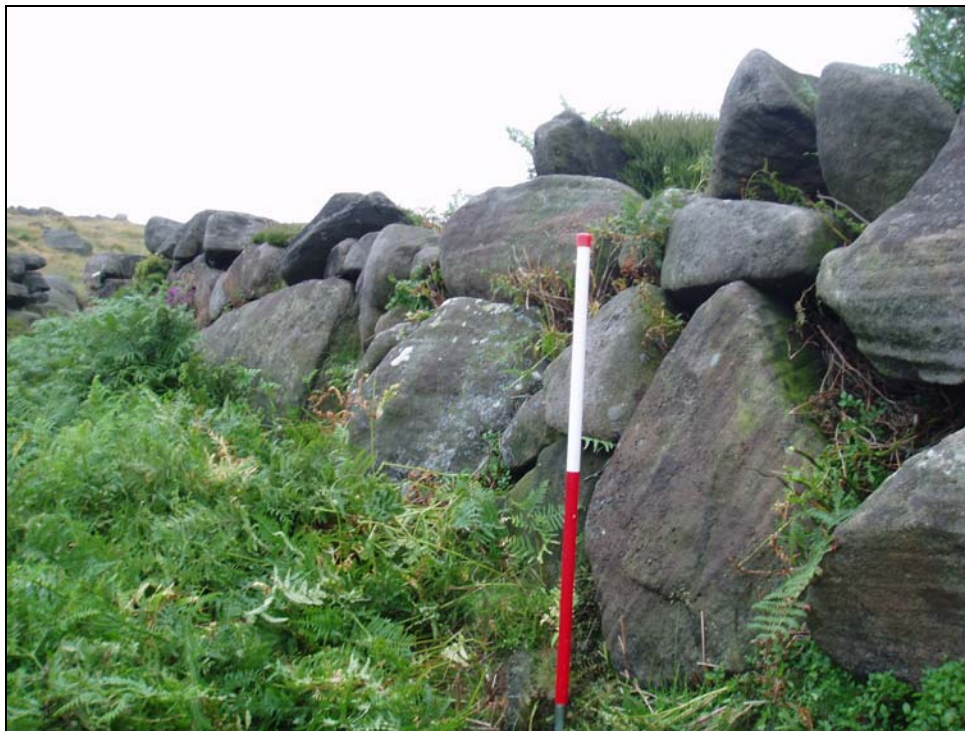
Illustration 15. Build of the southern wall of Carl Wark.

Most of Carl Wark is in good and stable condition. The southern enclosure wall has collapsed in the past, possibly in antiquity, but the tumble from previous collapse episodes currently appear to be stable.

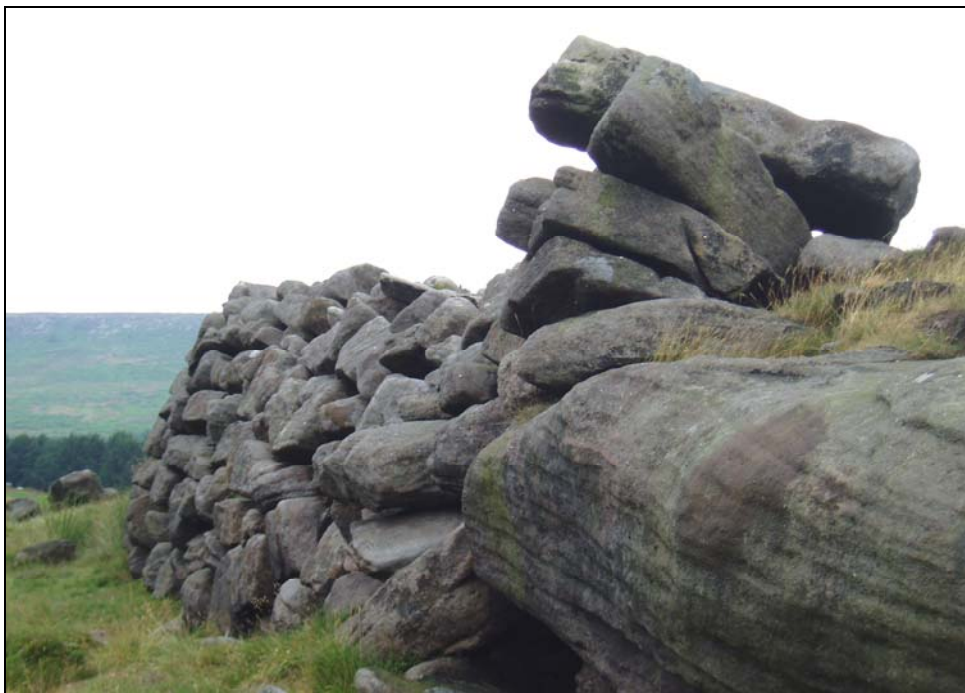
Illustration 16. Carl Wark's western rampart.

There is post-medieval millstone production concentrated outside of the eastern of the enclosure (feature 431.8). It has been speculated whether the enclosure wall was robbed for such later stone-working. The enclosure's western wall certainly was robbed to make a small building that is either medieval or post-medieval (431.2). Two things suggest that there was little robbing apart from this. All evidence for stone working is found below the enclosure's eastern end, over 130m away from the only obvious robbing. The only stone products identified during this survey were millstones, which require larger stones than were used in the enclosure wall. No gateposts, lintels, doorsteps, or other architectural elements have been

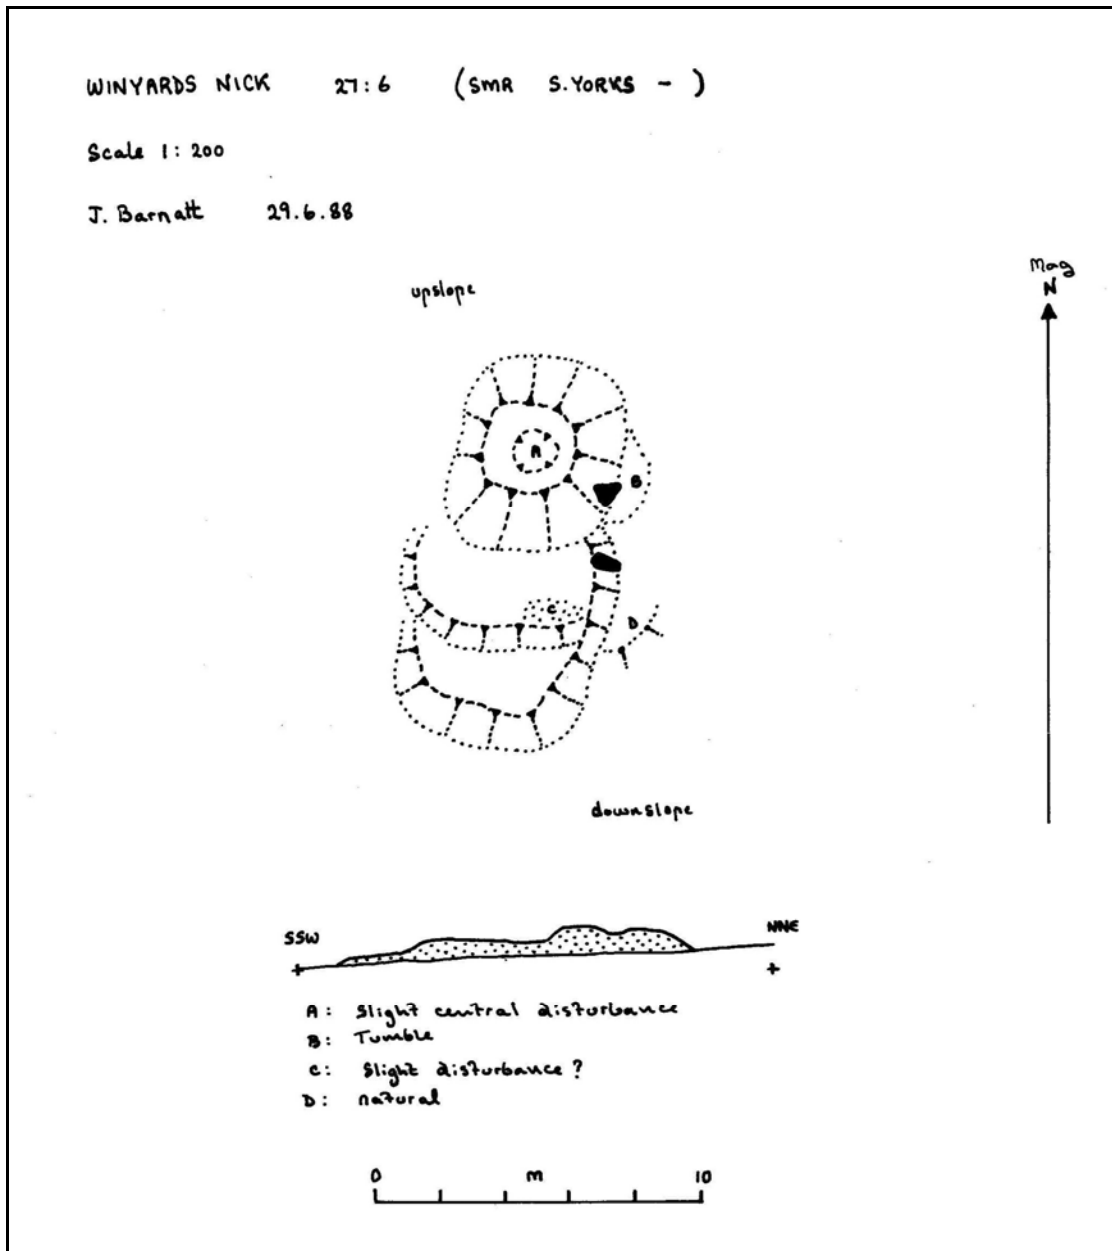
Illustration 20. Plan of Winyards Nick Burial Barrow. John Barnatt.

A stone sub-rectangular burial mound comprising 2-3 barrows or platforms adjoining each other. Approximately 12.5m long, 6m wide and 0.6m high. The feature(s) appear to be formed of two abutting or overlapping subrectangular platforms with a later subcircular barrow built over their northern edge. Together, they form a funerary site built during the later Neolithic to earlier Bronze Age, approximately 3500 to 4500 years ago. It is either a series of barrows for burying the dead or one-two excarnation platforms used for exposing the dead to the elements with a barrow added later. Whichever, and sometimes people changed between these two funerary practices at the same feature, it was enlarged and added to over time during prehistory showing the return to and reworking of this important burial site. There are many similar barrows and platforms throughout the Peak District (Barnatt 1996, 27.6), containing cremations placed in urns, inhumations or the 'left over' bones from excarnating a body. No archaeological excavations have been recorded, though a dished surface in the mound suggests possible robbing in the past. The archaeologist Leslie Butcher mentions urn and bronzes being found here in his field notes of a visit made in the 1950s.

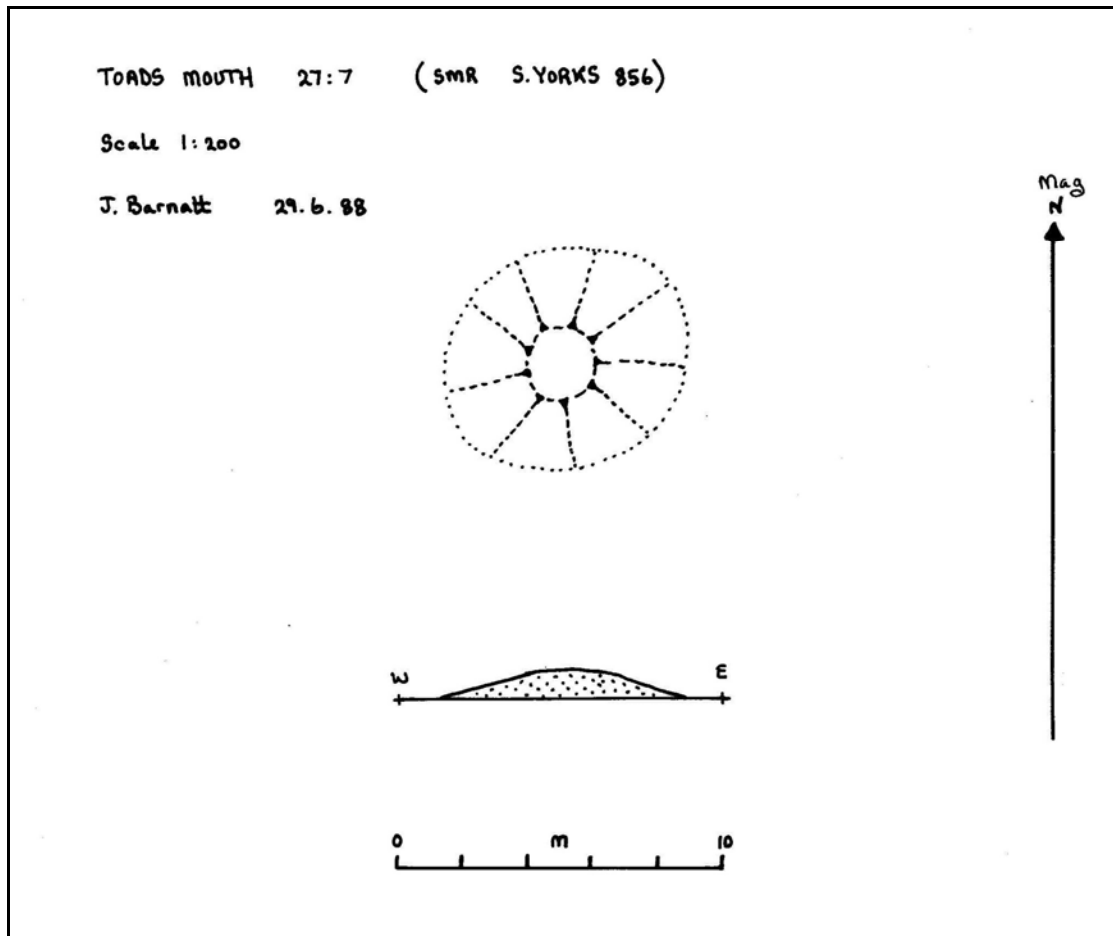
Illustration 22. Plan of Toads Mouth Burial Barrow. John Barnatt.

A small stone-built round barrow, approximately 8m in diameter and 0.9m high. It is a type of barrow built during the later Neolithic to earlier Bronze Age, approximately 3500 to 4500 years ago, as a location for burying the dead. Many similar barrows in the Peak District were constructed containing cremations placed in urns or inhumations (Barnatt 1996, 27.7). No burials have been found and no archaeological excavations have been recorded at this site, though the dished surface suggests possible robbing in the past. The barrow is built on the top of a gently-sloping knoll, which is only prominent from nearby. The barrow is located towards the north of the knoll and is only perceptible when seen from within a distance of 500m and in an arc between the north-west and north-east of the knoll. This makes the barrow visible from the cairnfield (feature 431.28) to the east and ring cairn (feature 431.27) to the north but invisible from anyone approaching from the south.

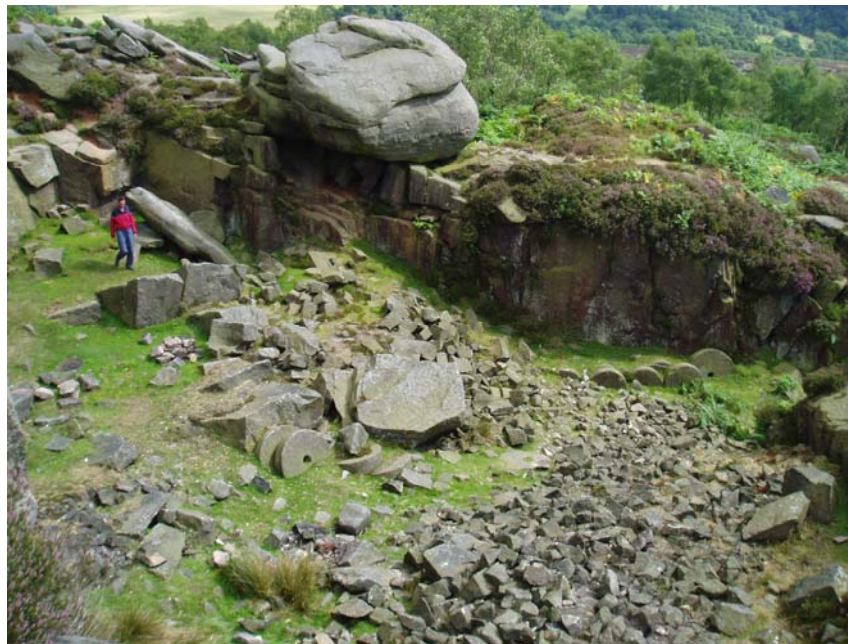
Illustration 23. Mothers Cap quarry.

A deep vertical-face quarry with associated crushing stones/millstones, quarry waste and a building. The quarry is approximately 40m long x 20m wide. It has been blasted into the scarp edge to create the vertical face. A narrow entrance leads into a triangular working area. Quarry waste forms a large, flat-topped spoil heap measuring approximately 30m x 40m. It is located immediately outside the entrance, which was used as a working area towards the latter part of the quarry's working life.

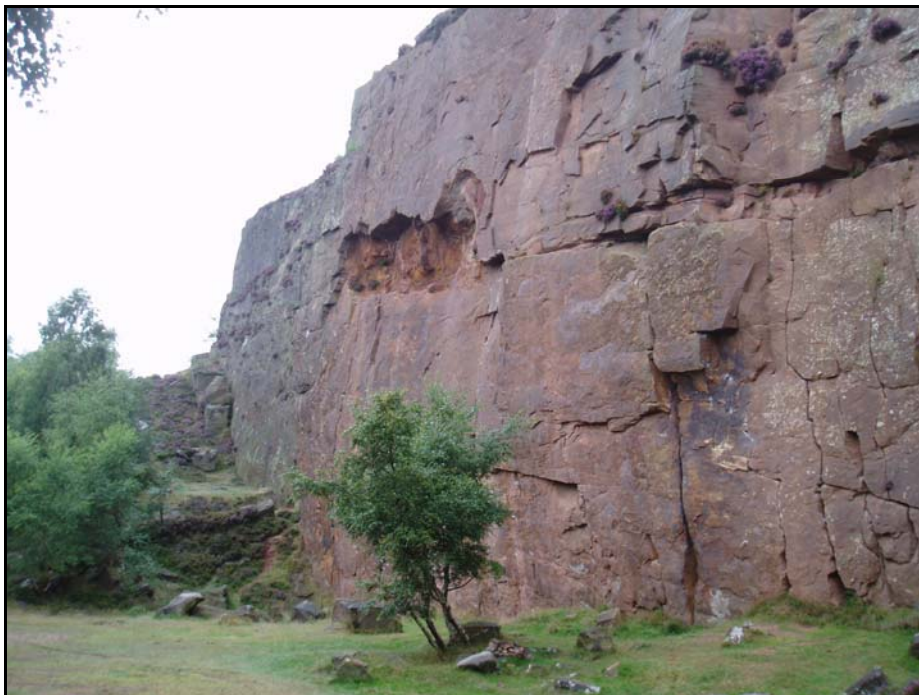
Illustration 24. Millstone Edge quarry face.

A large, deep vertical-face quarry with associated millstones/crushing stones, quarry waste, drill holes, buildings, associated structures and access tracks. The quarry is actually a series of individual working faces created along most of the length of the Millstone Edge natural scarp, formerly known as Booth Edge. The total area covered by quarry activity is approximately 650m long and 100m wide. Vertical and horizontal drill holes survive where the explosive charges were inserted into the rock. The faces are behind level working floors, from 20m to 40m deep, which are in part created by the act of quarrying itself and in part by the building up of quarry waste to form steep-sided spoil heaps that drop down below the edge. Further spoil mounds are piled to either side of each working faces.

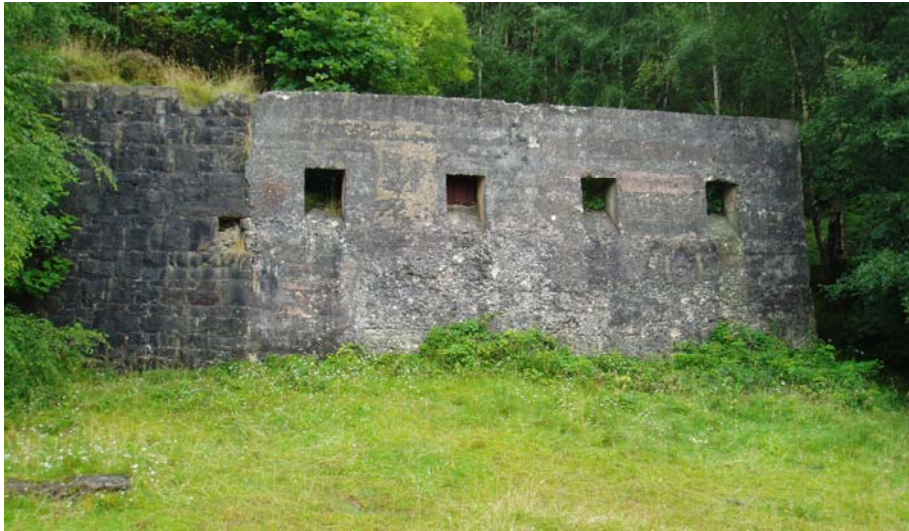
Illustration 25. Quarry building at Millstone Edge.

There are six buildings and other structures associated with the quarry.

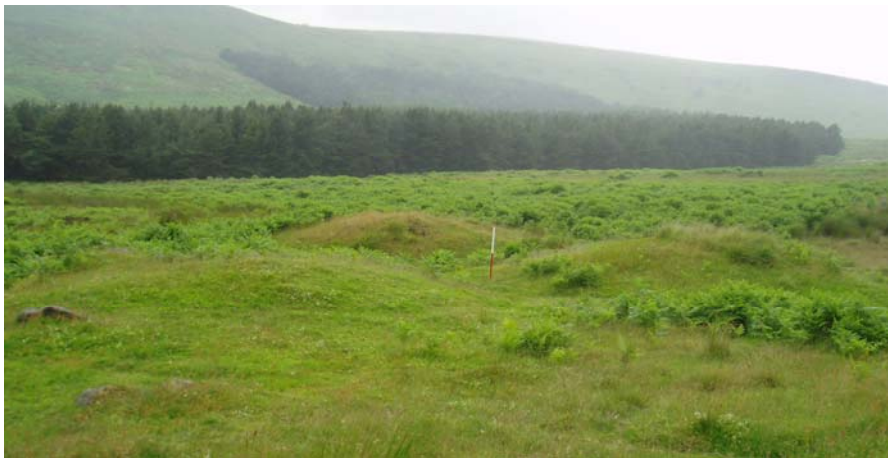
Illustration 26. Bloomery waste mounds.

Two areas containing mounds of industrial waste and an enclosure, separated from each other by 40m, represent the sites of two bloomeries.

The southern area comprises three mounds and a small, dry-stone walled enclosure are grouped within a 100m² area and represent the site of an iron-working hearth. The mounds are sub-circular and broadly similar in size: 7m x 6m x 0.8m, 9m x 6m x 1m and 7m x 3m x 0.5m. One of the mounds contains iron-smelting bloomery slag, which is eroding from the top of the feature. Adjacent to the southern mound is a small enclosure, approximately 3m x 1m across. The wall stands to 0.5m high. It is built against an earthfast, using the boulder to form one side of the enclosure, and gently slopes with the natural gradient of the valley side. There is no evidence for burning inside the enclosure.

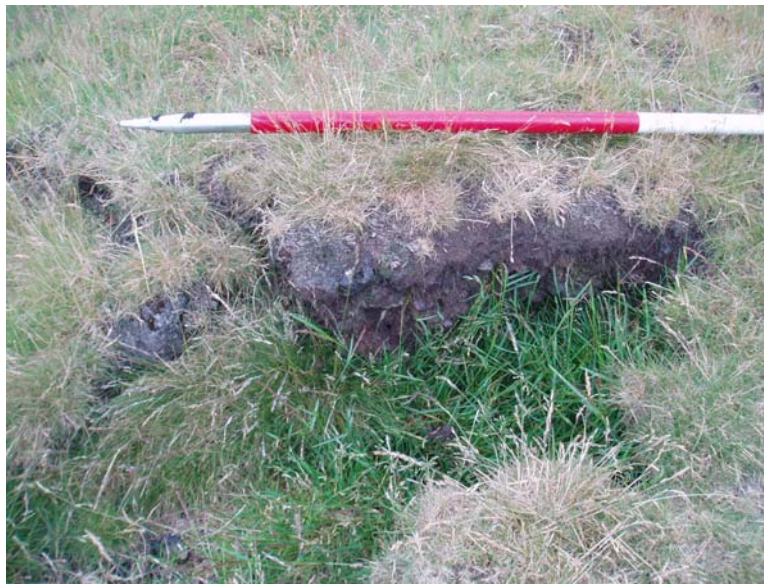
Illustration 27. Bloomery slag eroding from the top of a waste mound.

There are five mounds in the northern area, covering a similar area to the south. The mounds are subcircular: 2m x 2m x 0.5m, 4m x 4m x 0.5m, 6m x 5m x 0.7m, 9m x 5m x 0.6m and 12m x 8m x 2m. One mound has a shallow 1.5m x 1.0m square hole in the top. This could be the result of an excavation that was reputedly carried out somewhere in the bloomery complex in the 1980s (Daid Crossley pers. comm.).

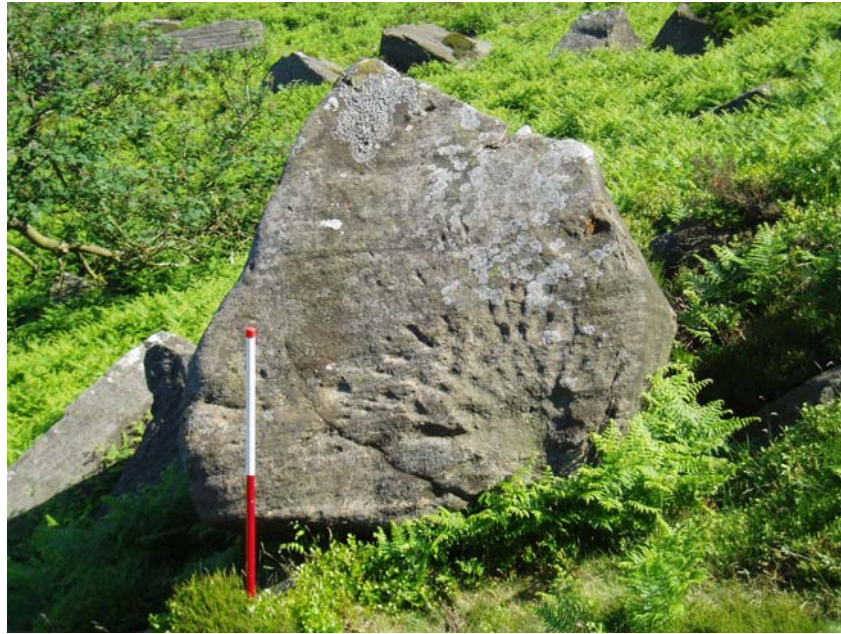
Illustration 29. Mortar scar on a boulder.

An extensive area below Burbage Edge contains numerous earthfast boulders which have been used for target practice. Each boulder is peppered with bullet holes, usually only on one side of each rock. There are also a number of boulders which have been hit by mortar shells, leaving a distinct explosive type scar. Towards the north end of the area are three silted foxholes, each approximately 2m by 2m wide, which might have been used for machine guns or mortars. One has distinct spoil heaps around three sides suggesting that whatever weapon was fired from it, faced north. Part of Burbage Edge to the north of the foxhole is covered in bullet holes and one mortar hit.

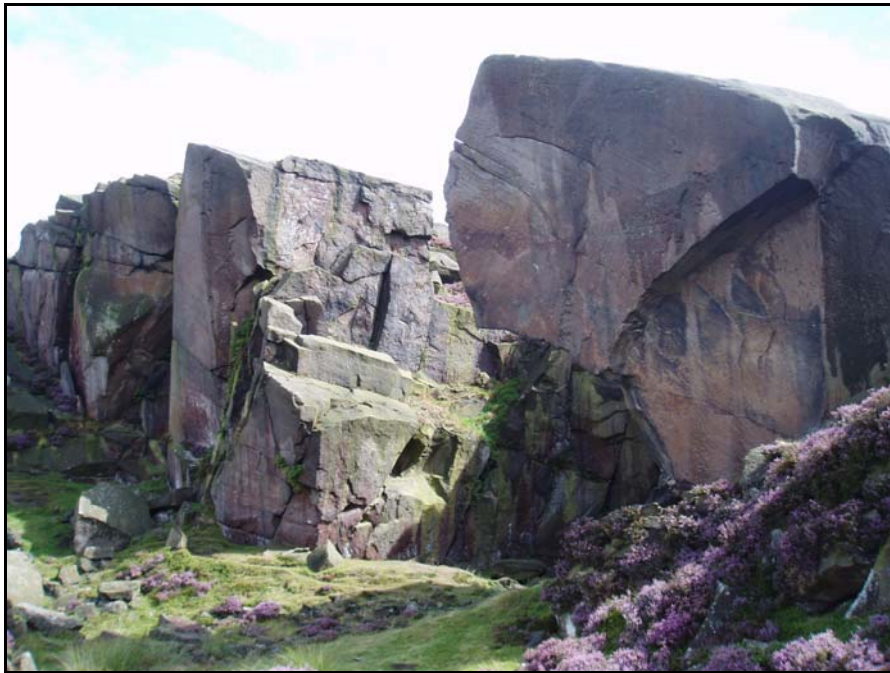
Illustration 31. Burbage Quarry quarry face.

A large, vertical-face quarry with associated millstones/crushing stones, quarry waste, drill holes, buildings and access tracks. The quarry comprises two individual working faces blasted into the Burbage Edge natural scarp. Quarry working may have also been undertaken along the edge between the two obvious faces, The total area covered by quarry activity is approximately 300m long and varies from 20m to 90m deep. Vertical and horizontal drill holes survive where the explosive charges were inserted into the rock. The faces are behind level working floors, from 10m to 20m deep, which are in part created by the act of quarrying itself and in part by the building up of quarry waste to form steep-sided spoil heaps that drop down below the edge. Further spoil mounds are piled to either side of each working faces.

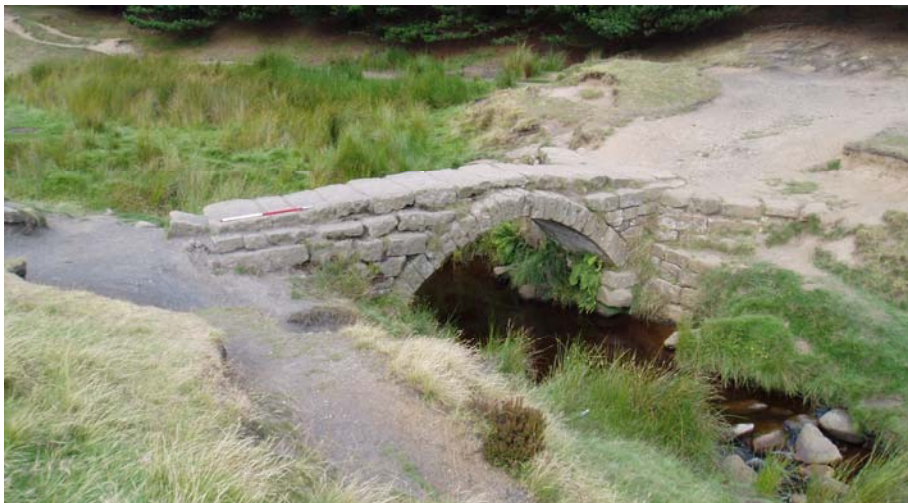
Illustration 32. Packhorse bridge.

A single-arch gritstone packhorse bridge crosses Burbage Brook just north of its confluence with another watercourse. The bridge is 1.8m high with a 3m long span. It is 1.5m wide and is topped with a 1m wide gritstone flag path.
